FRATCOF
Fire Behaviour of Steel and Composite Floor Systems
Review of Real Fires
 Dr. Renata Obiala 26th of May 2011

- **Cardington fire tests**
 - Beam test with burners
 - Frame test with burners
 - Corner tests with wood cribs
 - Demonstration tests with real office furniture
- **Fire tests of open car parks**
 - Localized car fire tests
- **Evidence from accidental fire in real buildings and other fire tests outside Europe**
 - Accidental fires
 - Other fire tests

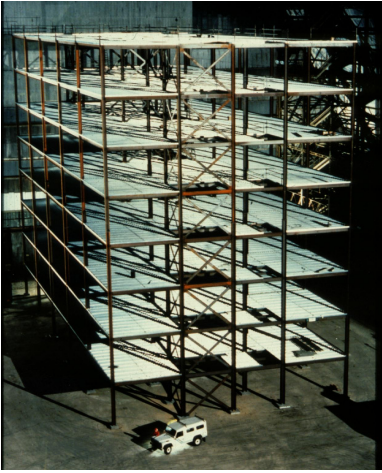
<ul style="list-style-type: none"> • Eight storey steel framed building <div style="display: flex; justify-content: space-around;"> <div data-bbox="501 474 884 945">

<p style="text-align: center;">Beam to beam joint</p> </div> <div data-bbox="922 712 1251 922">

<p style="text-align: center;">Beam to column joint</p> </div> </div>
<p>26th of May 2011</p>	<p style="text-align: center;">Review of real fires</p> <p style="text-align: right;">3</p>

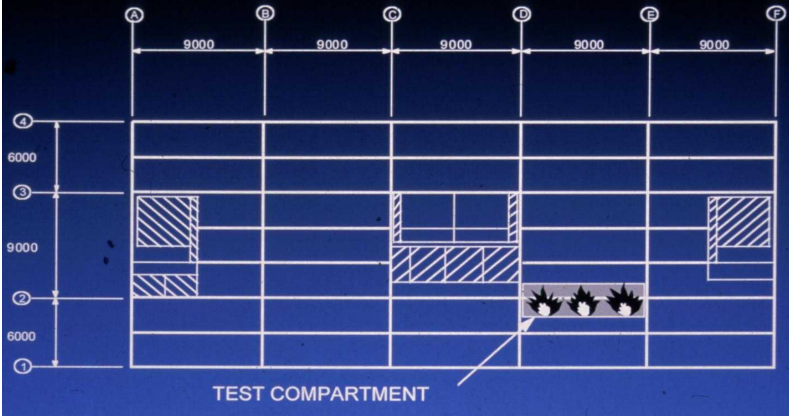
- Restrained beam test : span = 9.0 m

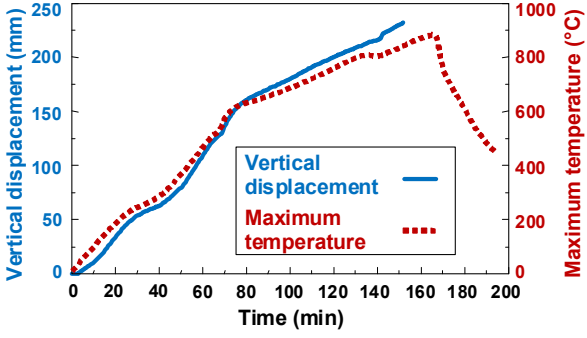
- Restrained beam test : experimental results

Time (min)	Vertical displacement (mm)	Maximum temperature (°C)
0	0	0
20	40	100
40	60	200
60	100	400
80	150	600
100	180	700
120	200	800
140	220	900
160	240	900
180	230	600
200	220	400

- Observation
 - Maximum heating $\approx 900\text{ }^{\circ}\text{C}$
 - Deflection of the beam: $< 250\text{ mm}$

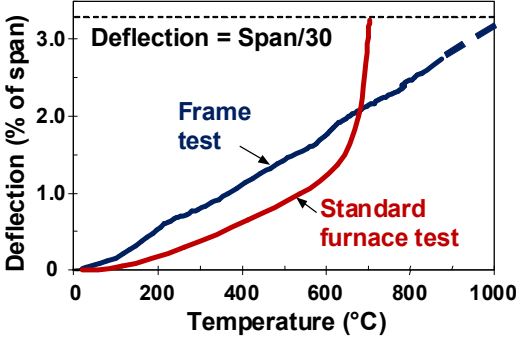
- Comparison with standard furnace fire test

The graph plots Deflection (% of span) on the y-axis (0 to 3.0) against Temperature (°C) on the x-axis (0 to 1000). A blue line represents the 'Frame test', showing a gradual increase in deflection to approximately 3.0% at 1000°C. A red line represents the 'Standard furnace test', showing a sharp increase in deflection starting around 600°C, reaching 3.0% at approximately 700°C. A horizontal dashed line at the top of the graph is labeled 'Deflection = Span/30'.

- Conclusion
 - No sign of failure in global composite floor system
 - Collapse at $\theta \approx 650^\circ\text{C}$ if simply supported

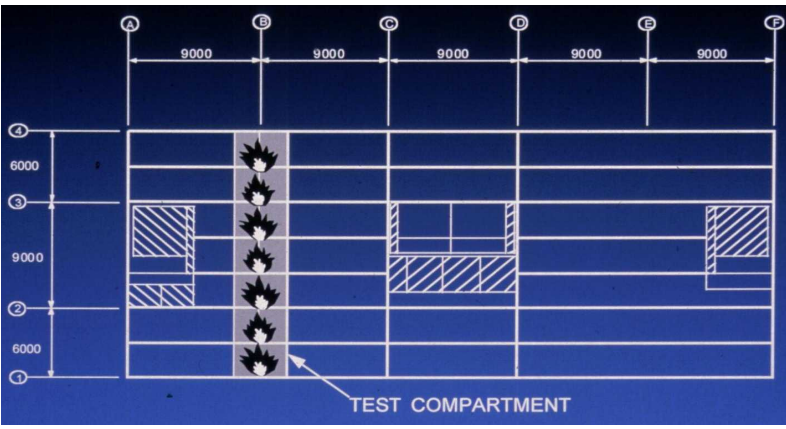
- Plane frame beam test

The diagram shows a structural frame with columns labeled A through F and beams labeled 1 through 4. The horizontal distance between columns is 9000 units. The vertical height of the beams is 6000 units. A 'TEST COMPARTMENT' is indicated at the bottom, with fire symbols shown on the beams between columns B and C, and between columns C and D.

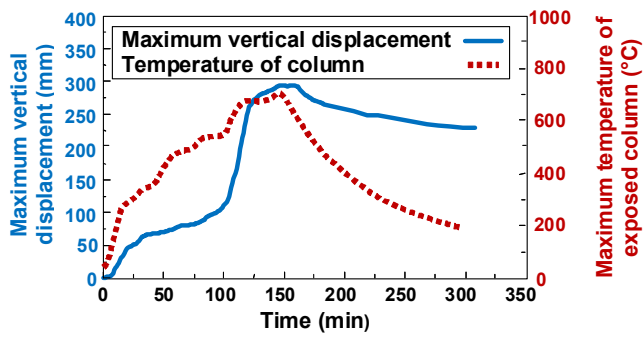
- **Plane frame test : experimental results**

Time (min)	Maximum vertical displacement (mm)	Maximum temperature of exposed column (°C)
0	0	0
50	75	400
100	125	600
150	300	750
200	275	500
250	250	350
300	240	250

- **Observation**
 - Maximum heating $\approx 750\text{ }^{\circ}\text{C}$
 - Deflection of the beam $\approx 300\text{ mm}$

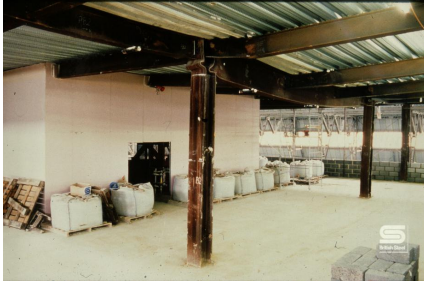
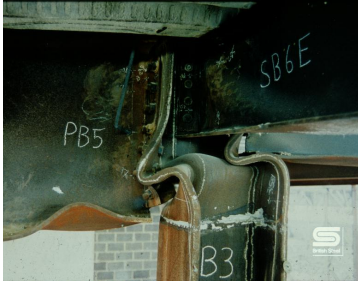
- **Deformed state of heated part of the floor**

- **Conclusion**
 - Squashing of unprotected part of column
 - No further collapse despite above local failure

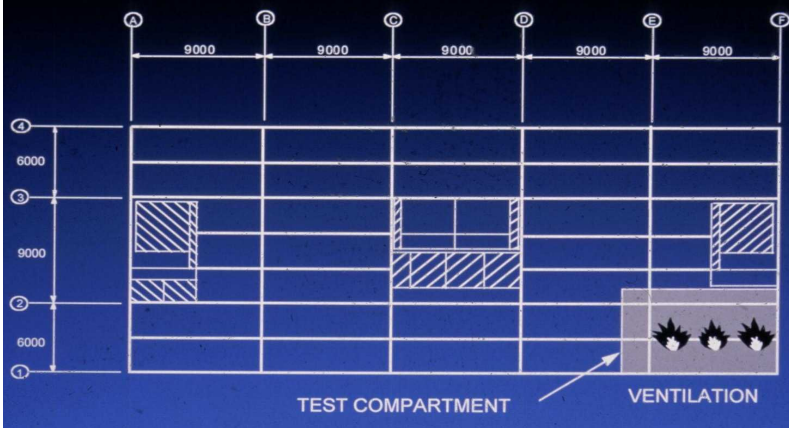
- **Corner compartment test**

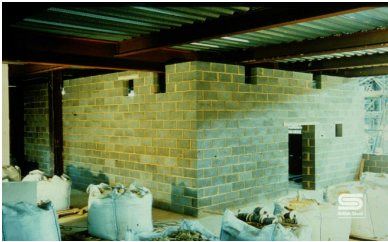
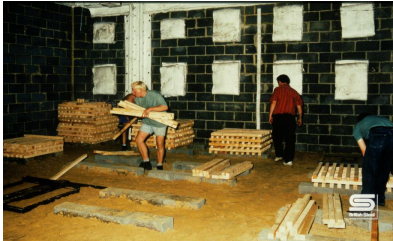
- **Corner compartment test : set-up**

Fire load with wood cribs equals to 45 kg/m²

Walls of the compartment with hollow breeze-blocks

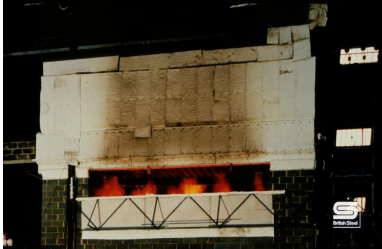
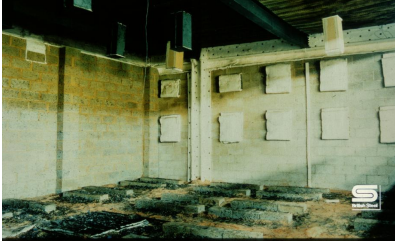
- **Corner compartment test : experimental results**

Fire during the test

Deformed floor after the test

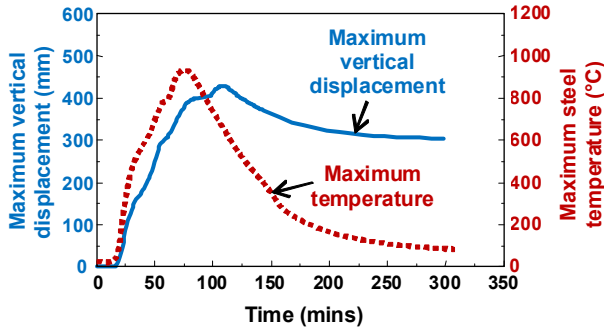
- **Corner compartment test : experimental results**

- **Observation**
 - Maximum heating of steel $\approx 1014\text{ }^{\circ}\text{C}$
 - Maximum deflection of the floor $\approx 428\text{ mm}$

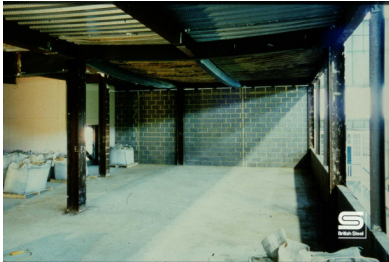
Deformed state of the heated part of the composite floor

- **Conclusion**
 - No sign of global failure of the floor as well as limited deflection of the floor despite important heating of steel

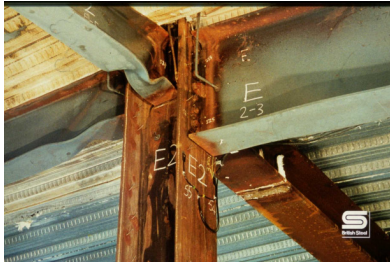
Deformed state of steel members around protected steel column

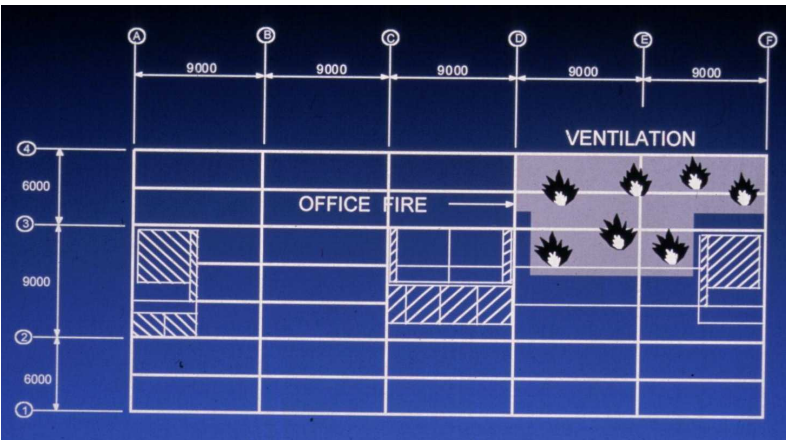
- **Demonstration test (an area of more than 130 m²)**

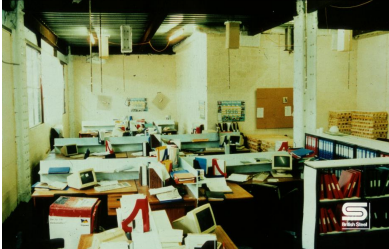
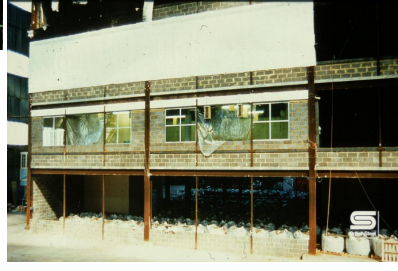
<ul style="list-style-type: none"> Demonstration test : set-up <div style="display: flex; justify-content: space-around;"> <div data-bbox="478 481 869 728">

<p style="text-align: center;">Fire load with real office furniture</p> </div> <div data-bbox="869 481 1276 952"> <p style="text-align: center;">Openings with normal glazed windows</p>

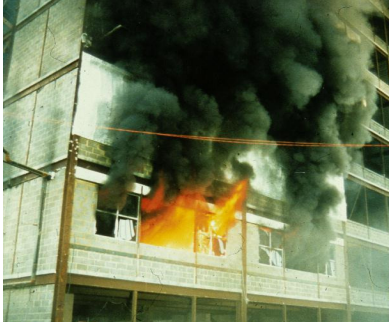
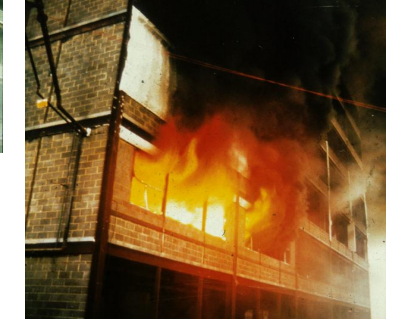
<ul style="list-style-type: none"> Demonstration test : experimental results <div style="display: flex; justify-content: space-around;"> <div data-bbox="478 1400 869 1724">

<p style="text-align: center;">Early stage of fire</p> </div> <div data-bbox="869 1400 1276 1892"> <p style="text-align: center;">Fully developed fire</p>

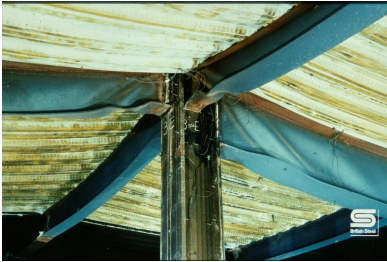
<p style="text-align: center;">Deformed state of steel members around protected steel column</p> </div> </div> <ul style="list-style-type: none"> • Conclusion <ul style="list-style-type: none"> – No sign of global failure of the floor <u>despite important heating of steel and deflection of the floor</u>
<p>26th of May 2011</p>	<p style="text-align: center;">Review of real fires</p> <p style="text-align: right;">21</p>

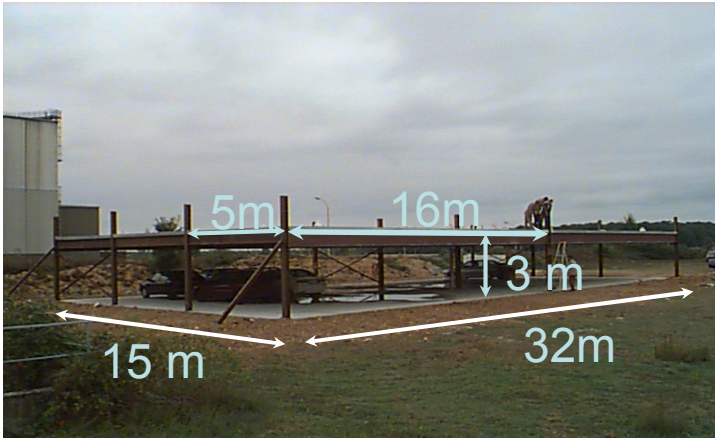
<ul style="list-style-type: none"> • One storey steel framed building

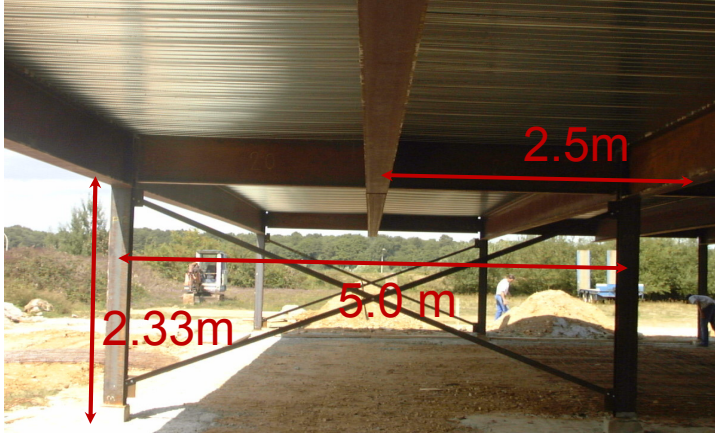
</div> <ul style="list-style-type: none"> • One storey steel framed building

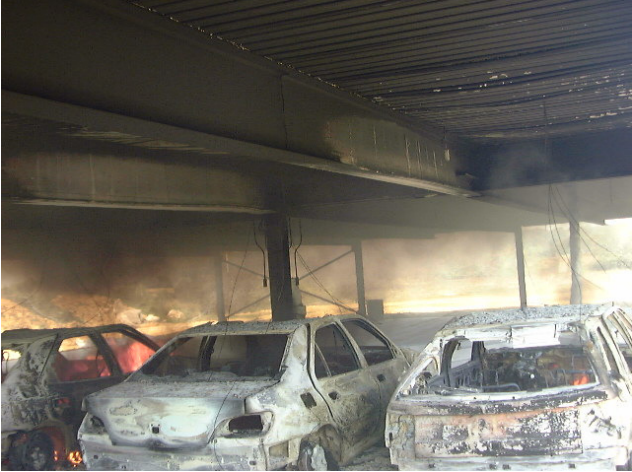
Evidence from accidental fire	62 min		
26 th of May 2011	Review of real fires	31

Fire tests of open car parks	• Experimental results (test 1)

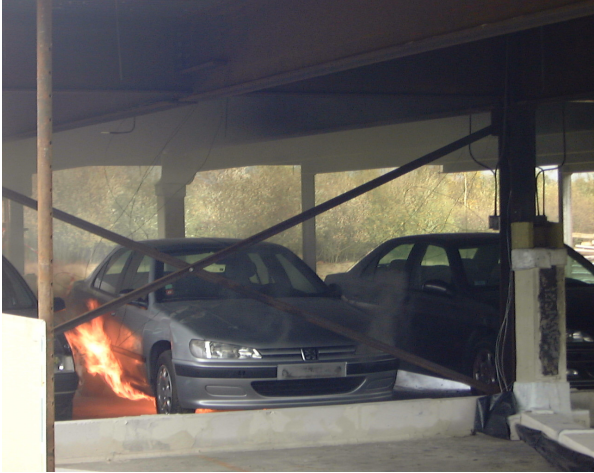
Evidence from accidental fire	0 min		
26 th of May 2011	Review of real fires	32

Fire tests of open car parks	• Experimental results (test 2)

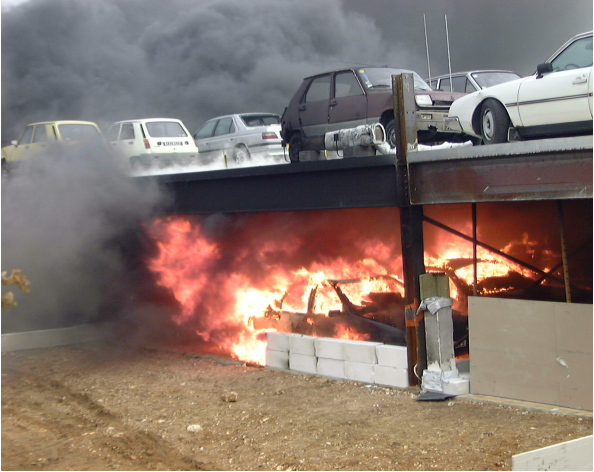
Evidence from accidental fire	10 min		
26 th of May 2011	Review of real fires	33

Fire tests of open car parks	<ul style="list-style-type: none">• Experimental results (test 2)

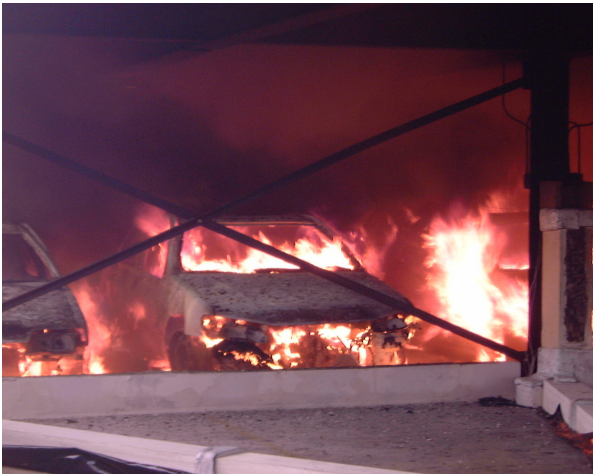
Evidence from accidental fire	25 min		
26 th of May 2011	Review of real fires	34

Fire tests of open car parks	<ul style="list-style-type: none">• Experimental results (test 2)

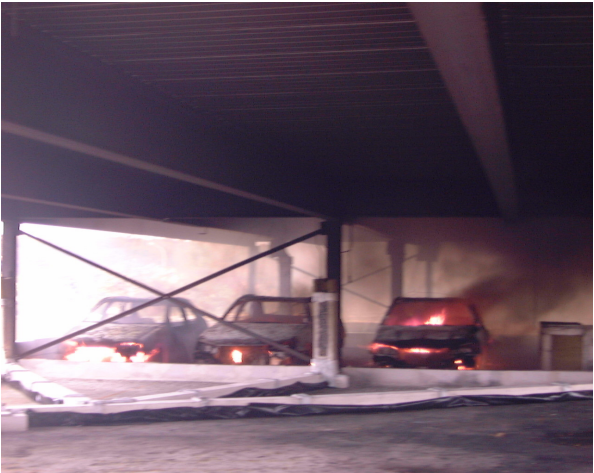
44 min

- **Experimental results (test 2)**

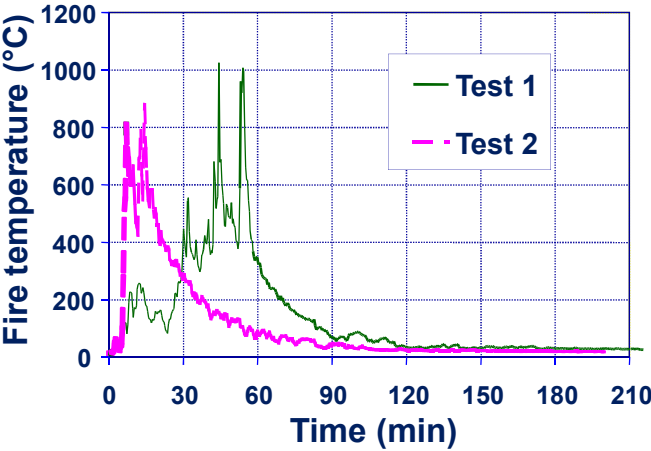
- **Experimental results : gas temperature**

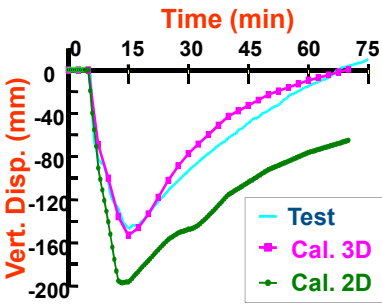
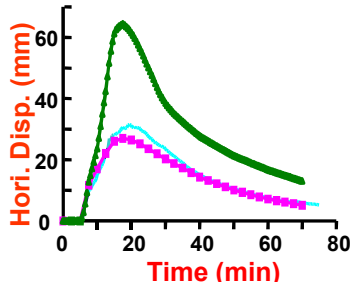
- **Effects of 3D membrane effect**

- **Conclusion**
 - Reduction of displacements with 3D membrane effect compared to 2D portal frame behaviour

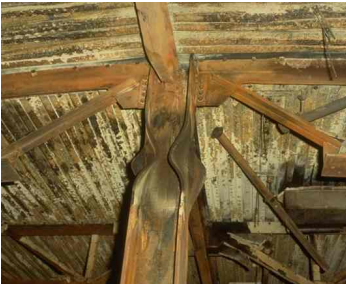
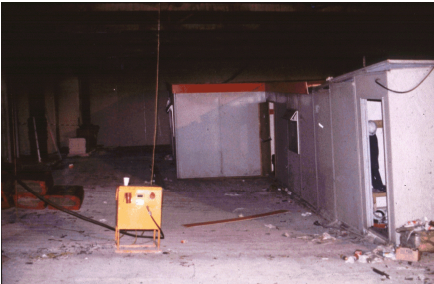
- **Broadgate fire**
 - 14 storey-office building with composite floor system
 - Fire temperature more than 1000 °C
 - Important deflection of the floor (more than 600 mm) but no collapse

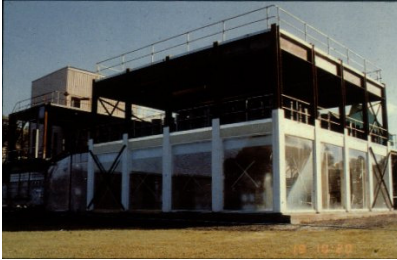
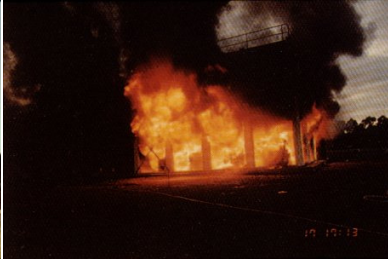
<ul style="list-style-type: none"> • Australian fire tests <ul style="list-style-type: none"> – Full scale composite floor system – Fire load: 52 kg/m² of wood cribs – Fire temperature more than 1228 °C – No collapse of the floor <div style="display: flex; justify-content: space-around;">
